Test object: TA IQ RWD
Manufacturer: TA Service TA Service A/S Orupgade 32 B
4640 Faxe . Denmark

Certificate of testing

Crash Test according to ISO 10542-5 & ISO 7176-19 - 2012

**Wheelchair tiedown and occupant-restraint systems.
Systems for specific wheelchairs**

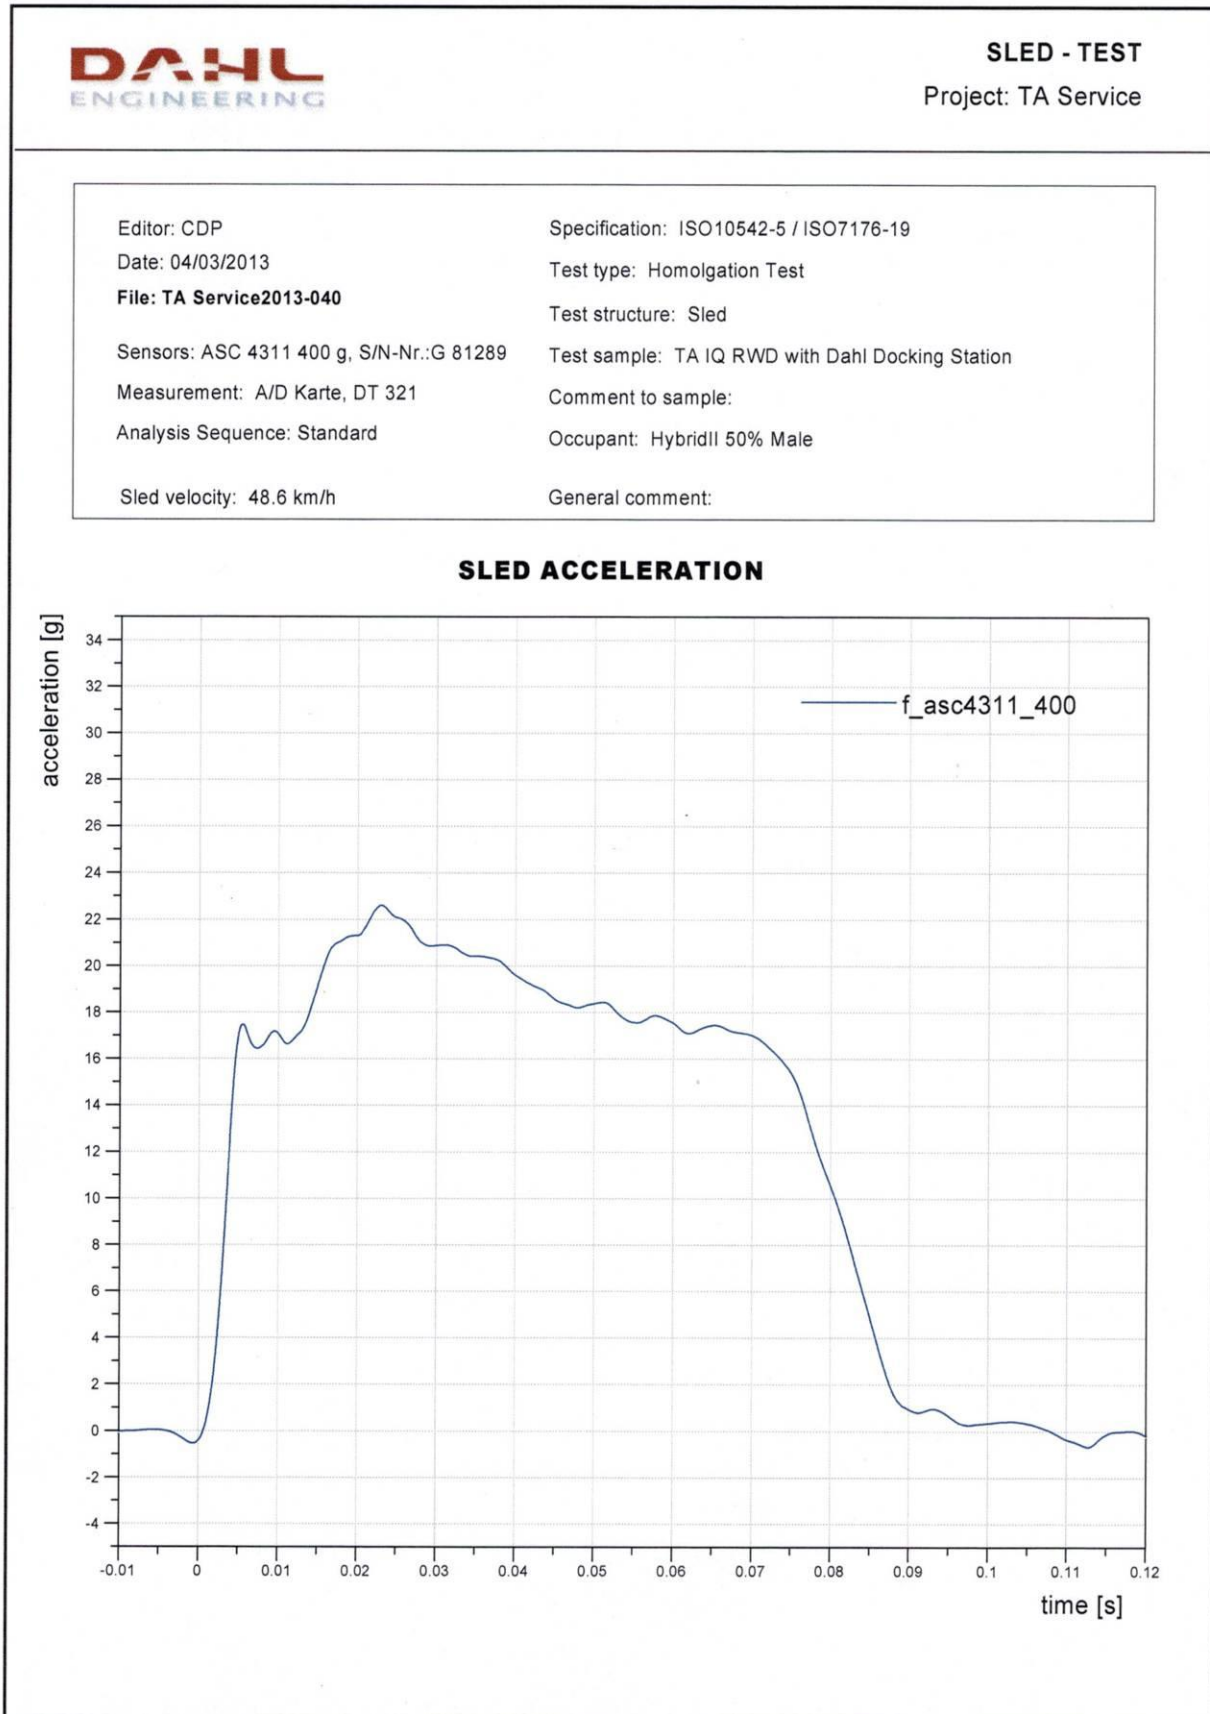
Plotted graph and speed

Sled deceleration and speed: See page with plotted graph and speed
