Test object: TA IQ RWD
Manufacturer: TA Service TA Service A/S Orupgade 32 B
4640 Faxe . Denmark

Certificate of testing

Crash Test according to ISO 10542-5 & ISO 7176-19 - 2012

**Wheelchair tiedown and occupant-restraint systems.
Systems for specific wheelchairs**

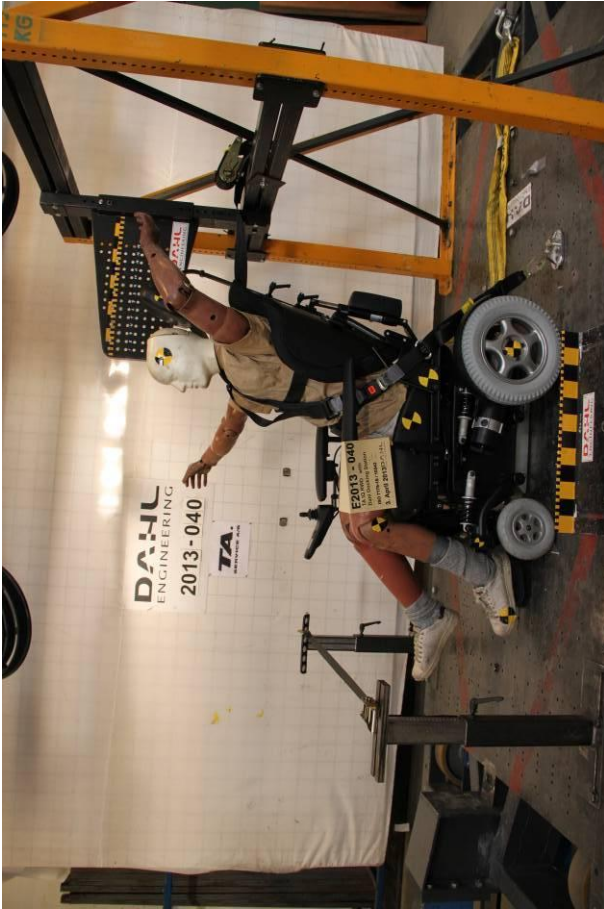
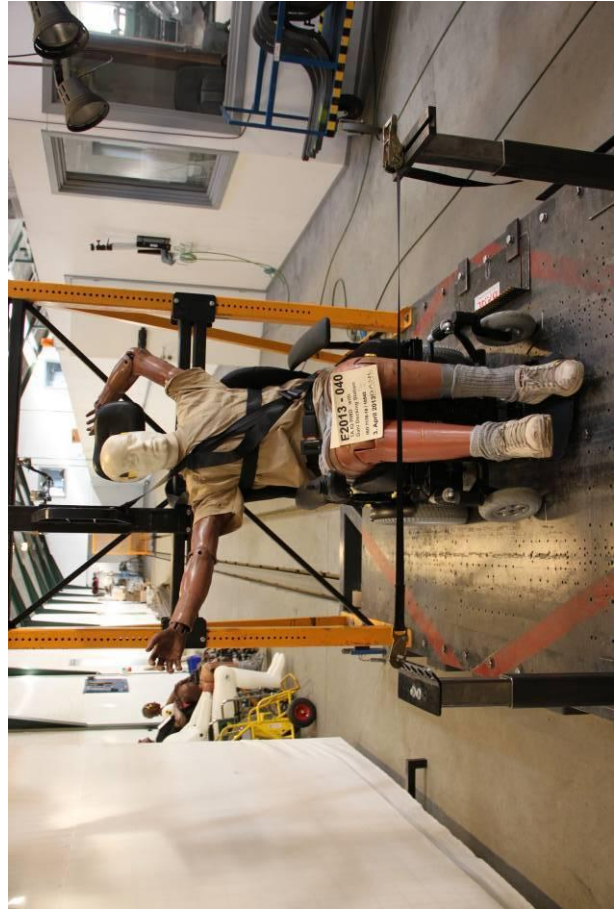
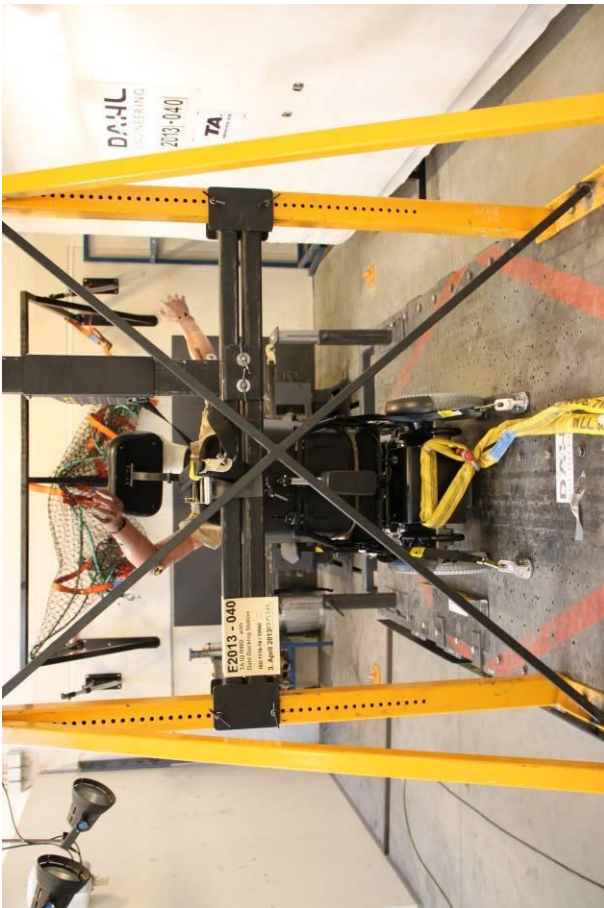
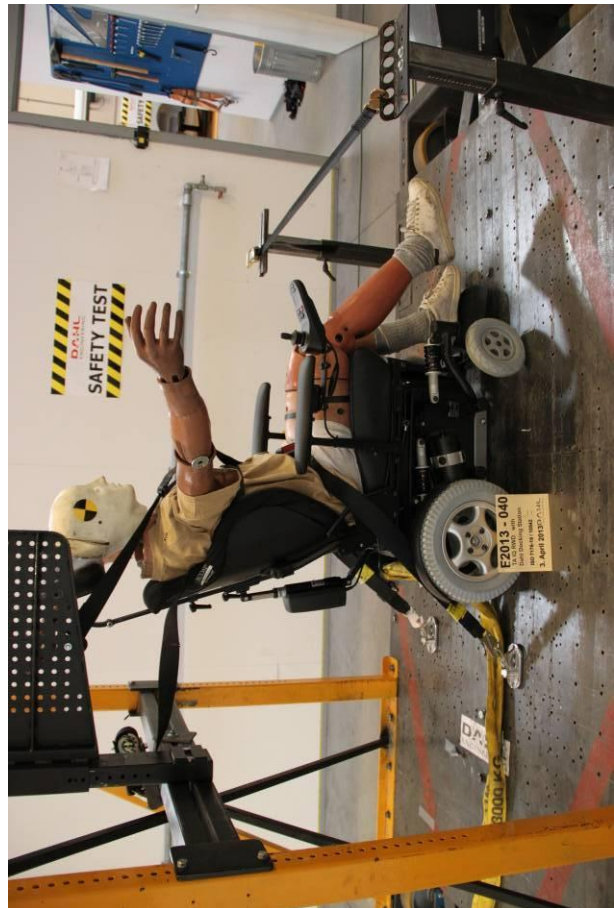
Post- test photos

(b)	There were no visible signs of material failure on the wheelchair securing points	X
(c)	There were no components, fragments or accessories of the wheelchair with a mass of more than 100g that completely separated from the wheelchair	X

(d)	There were no fragmented or separated component, that may contact the occupant, produced with sharp edges less than radius 2 mm	X
(e)	There were no visible signs of failure on the wheelchairs primary load carrying components	X

(f)	There were no visible signs of failure on the wheelchairs seat adjusters	X
(g)	The ADT was removed from the wheelchair without the use of tools	X
(h)	The wheelchair was released from the tie-down system without the use of tools	X
