Test object: TA IQ MWD
Manufacturer: TA Service TA Service A/S Orupgade 32 B
4640 Faxe . Denmark

Certificate of testing

Crash Test according to ISO 10542-5 & ISO 7176-19 - 2012

**Wheelchair tiedown and occupant-restraint systems.
Systems for specific wheelchairs**

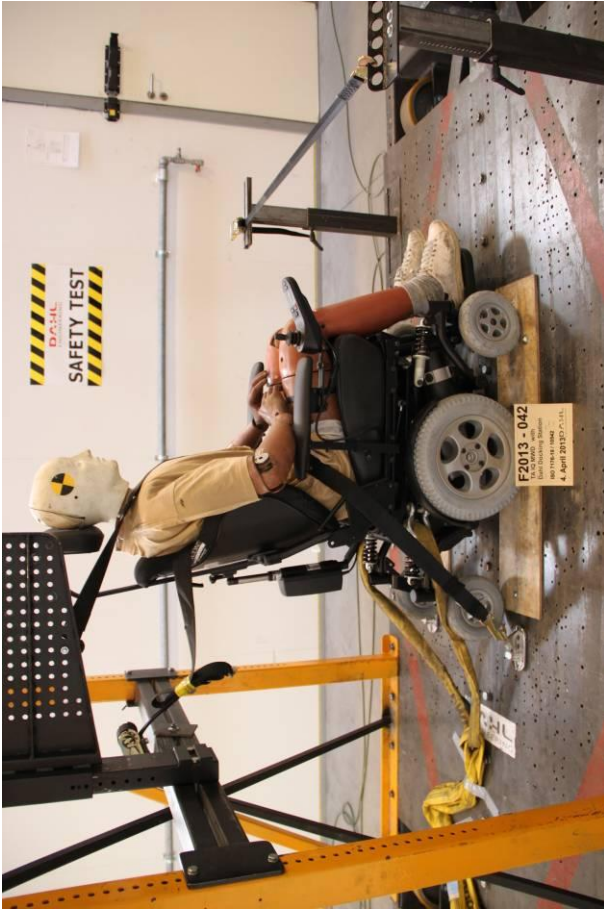
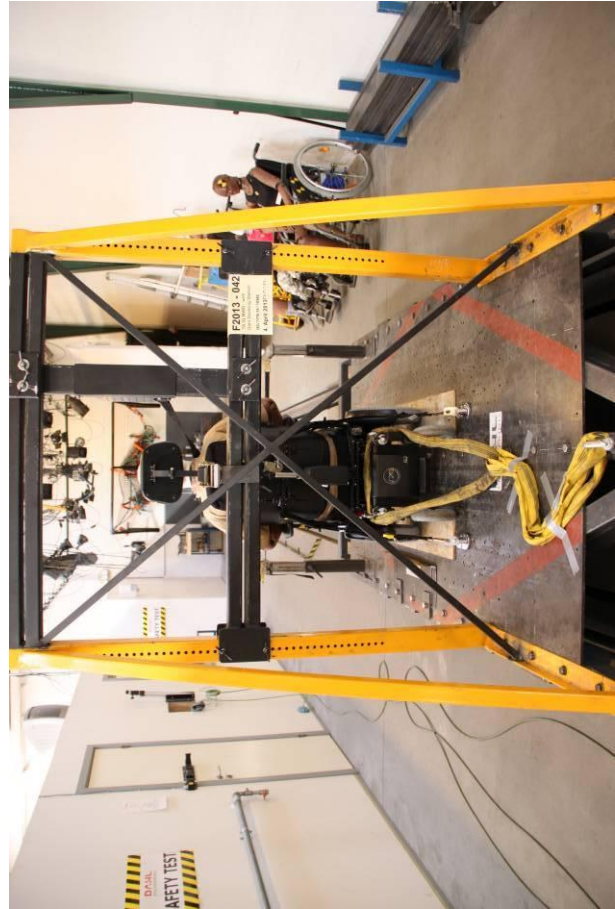
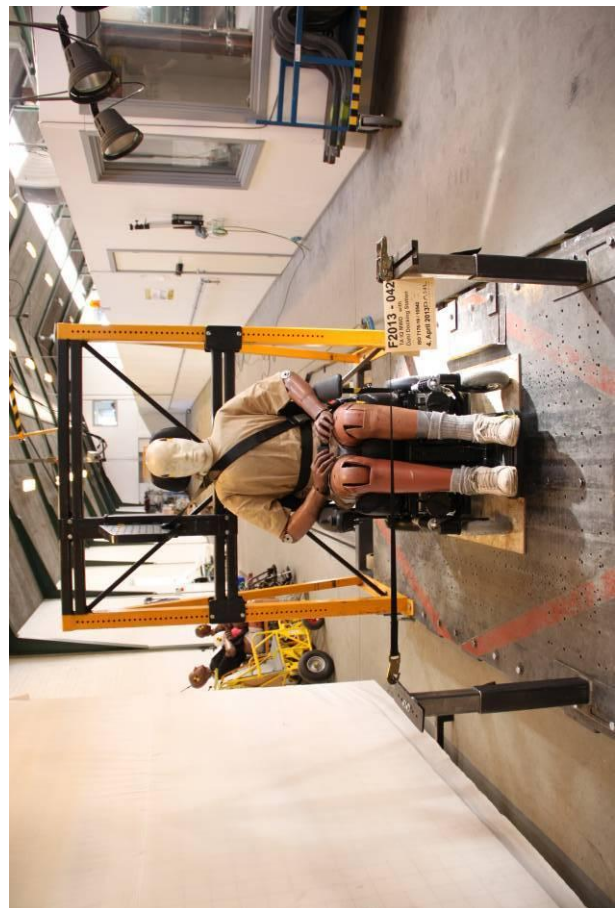
Pre- test photos

Photography: The test was filmed with a high speed camera at 500 fps. Still pictures, pre and post test, was also taken.
