Certificate of testing

Crash Test according to ISO 7176-19 - 2008

Assignment: Crash testing of wheel chair and WTORS according to ISO 7176-19 annex A and B

Test object: TA Indoor Wave wheelchair

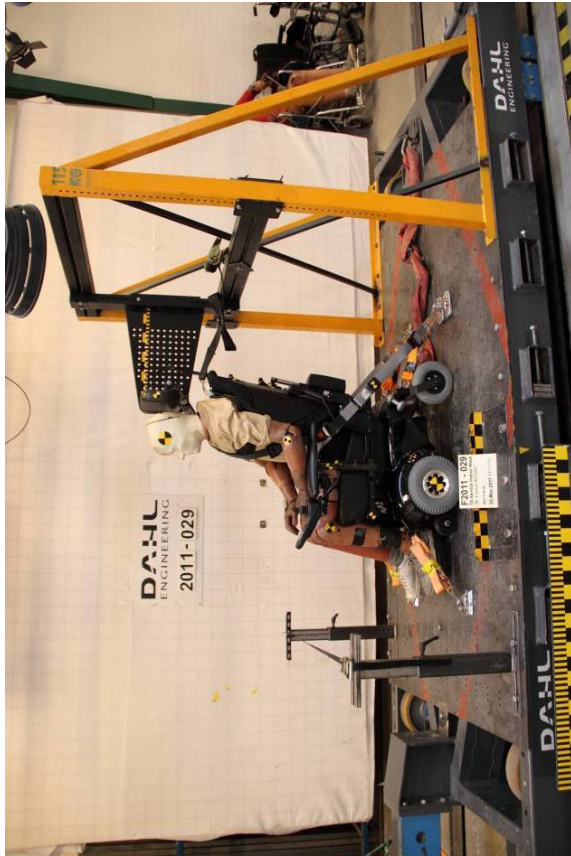
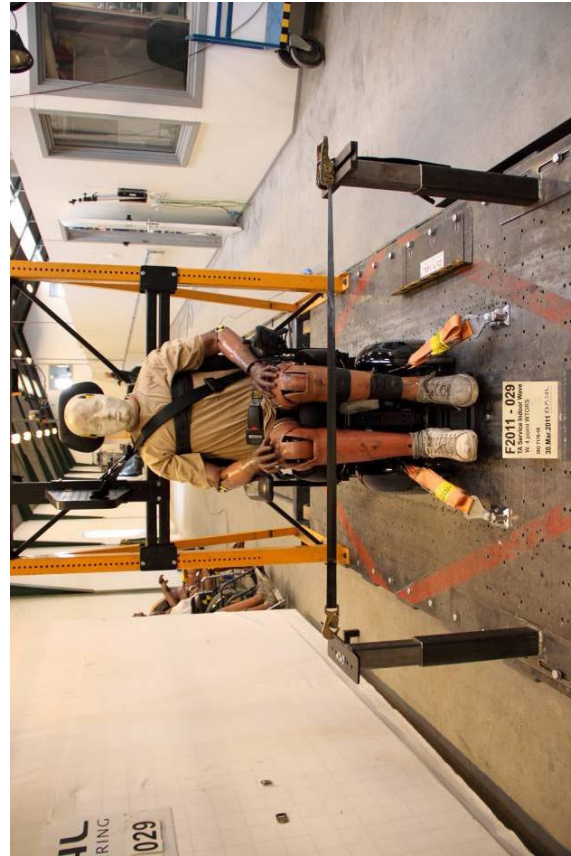
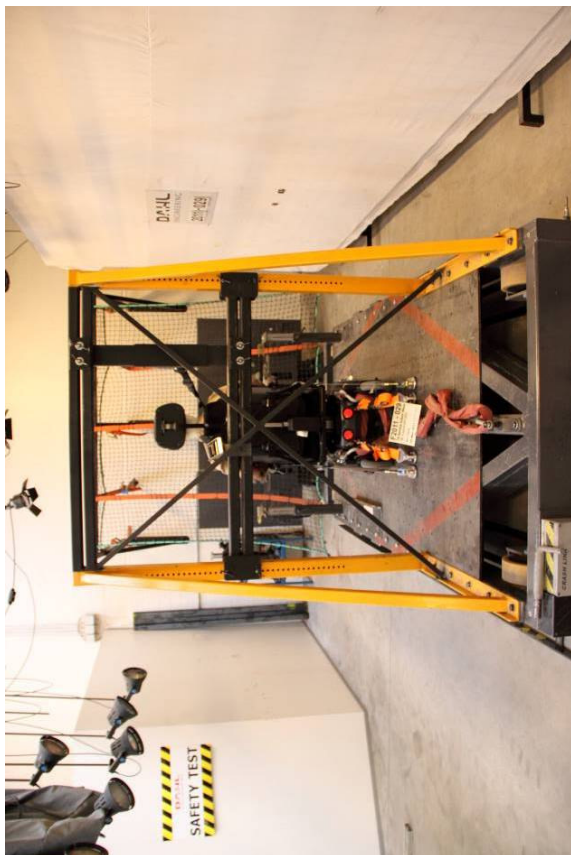
Pre- test photos

Photografi: The test was filmed with a high speed camera at 500 fps.
Still pictures, pre and post test, was also taken.

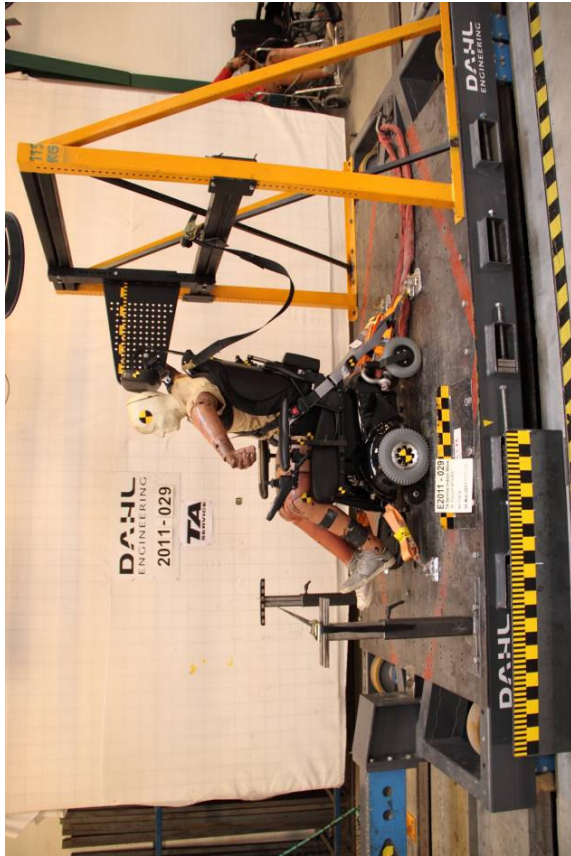
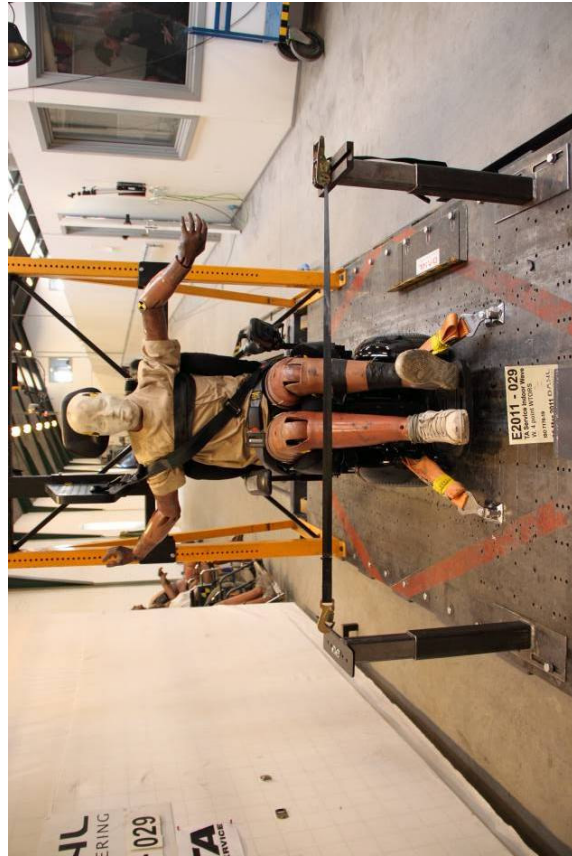
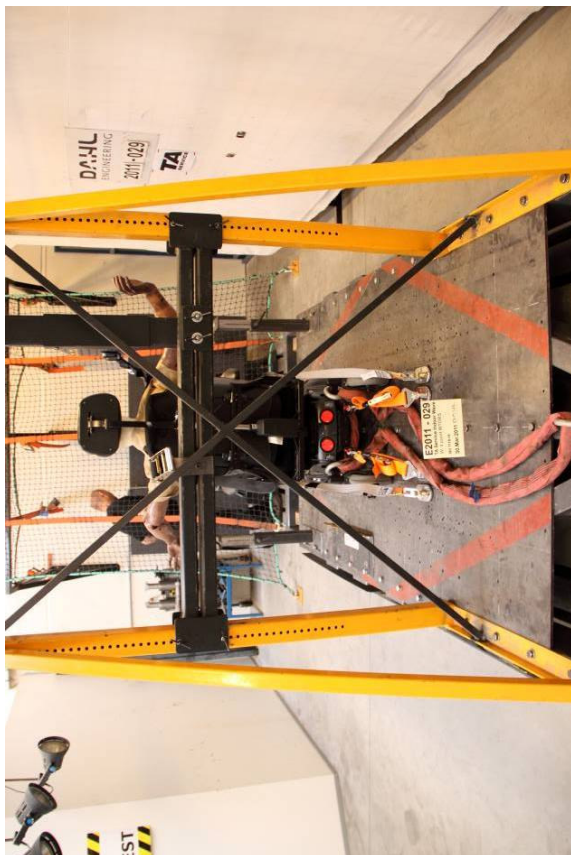
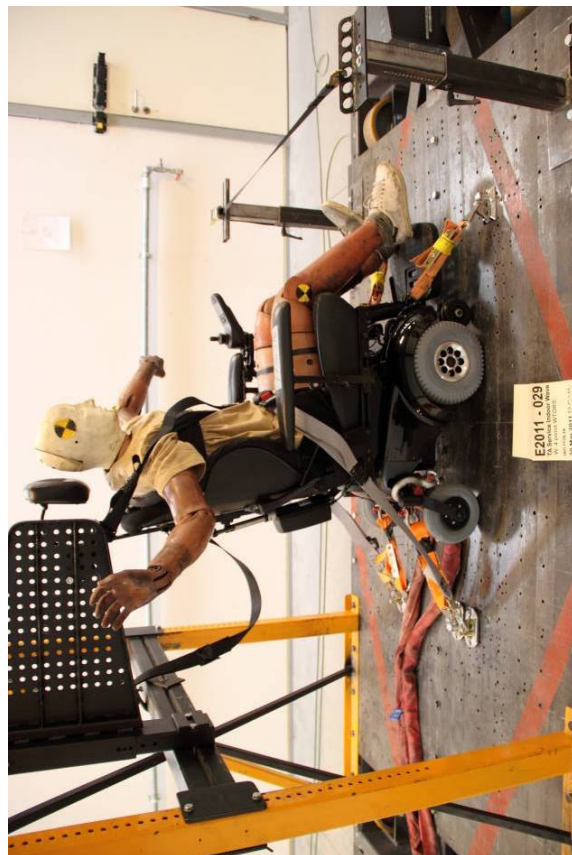
Post test photos

5.2.2	After the test	
(a)	The wheelchair remained in an upright position on the platform	X
	The ADT remained in the wheelchair with its torso at an angle of not more than 45° to the vertical, when viewed from any direction	X

(b)	There were no visible signs of material failure on the wheelchair securing points	X
(c)	There were no components, fragments or accessories of the wheelchair with a mass of more than 100g that completely separated from the wheelchair	X

(d)	There were no fragmented or separated component, that may contact the occupant, produced with sharp edges less than radius 2 mm	X
(e)	There were no visible signs of failure on the wheelchairs primary load carrying components	X
